Technical Service Bulletin

June 16, 2023

Rotel Bluetooth 5.1 aptX[™] HD Module

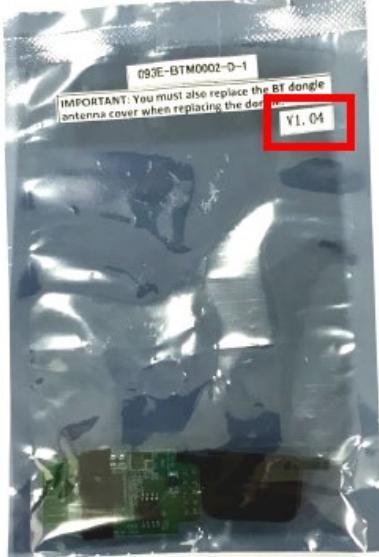
1. Check and ensure a printed label with text "V1.04" being pasted on plastic package.

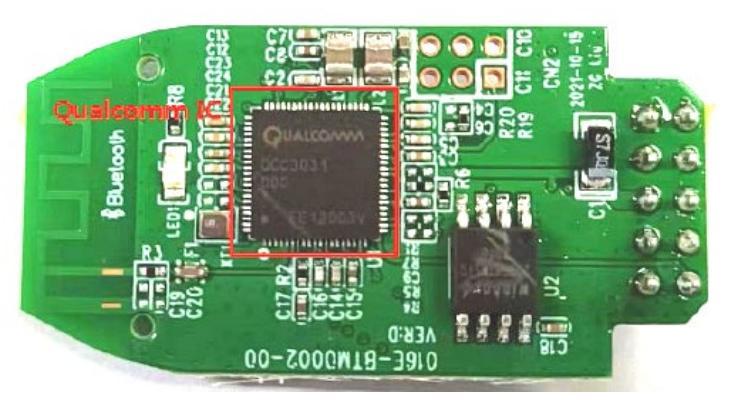
• New Bluetooth module 5.1 built Qualcomm IC as below photo.
